**USE OF REMOTELY SENSED DATA AND GIS TECHNIQUES
FOR ASSESSMENT OF WATERLOGGED AND SALT-AFFECTED AREA
TEHSILWISE IN MUKTSAR DISTRICT OF PUNJAB**

C.M.Bhatt¹, R.K.Singh², P.K.Litoria³ and P.K.Sharma³

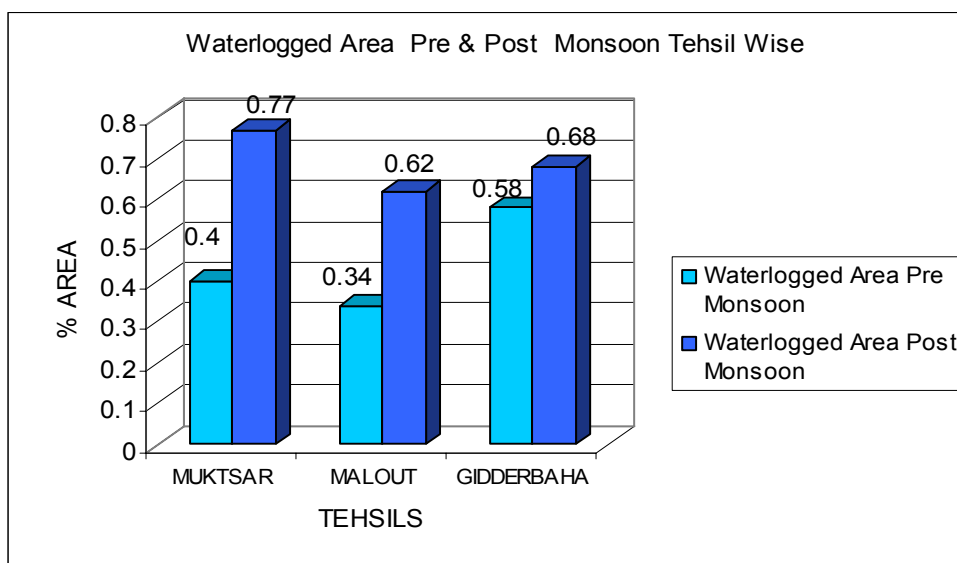
Figure 6. Relationship between waterlogged area during pre and post monsoon tehsil wise.

The relationship between pre and post monsoon waterlogged area (Figure6) shows that increase in waterlogged area for Muktsar tehsil (increase of 0.37%) is maximum and for Gidderbaha tehsil (increase of 0.10%) it's the minimum. The relationship between waterlogging and salinity for pre monsoon season (Figure7) shows that for all tehsils area under salinity is more except for Gidderbaha tehsil, where area under waterlogging is more.

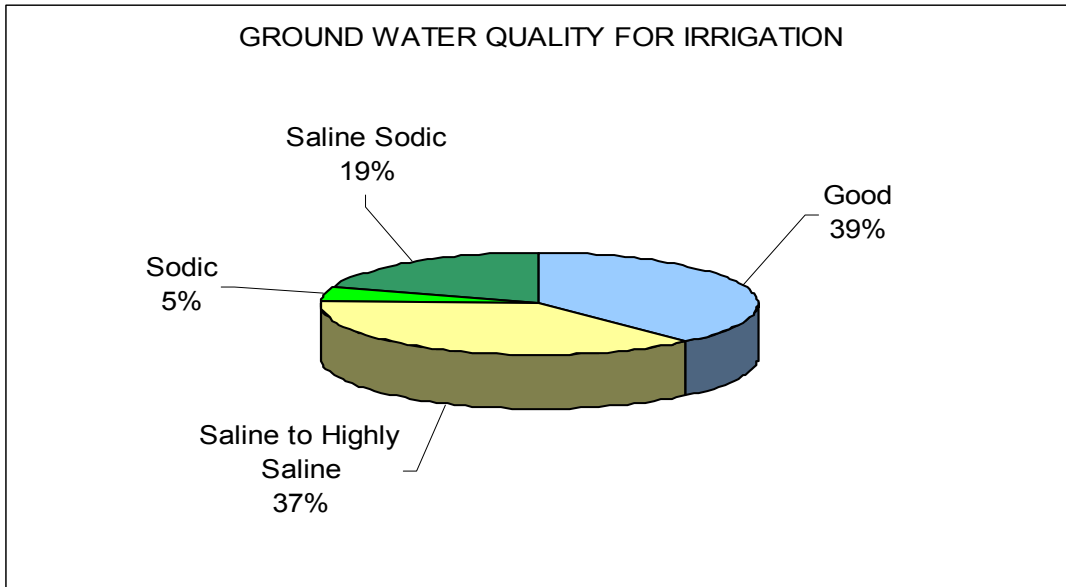
Figure 8. Area under different ground water quality zones in Muktsar district.

2) **Brackish quality of groundwater:** Due to the brackish nature exploitation of groundwater is less than 60% of its annual utilization. Nearly 61% (Figure8) area of the district has poor quality groundwater out of which 37% area has saline to highly saline, 19% has saline-sodic and 5% area has sodic waters (Sharma et.al.,2003).The erratic rainfall and water allocation to farmers meet only about 50% of the demand, hence the farmers are forced to make use of

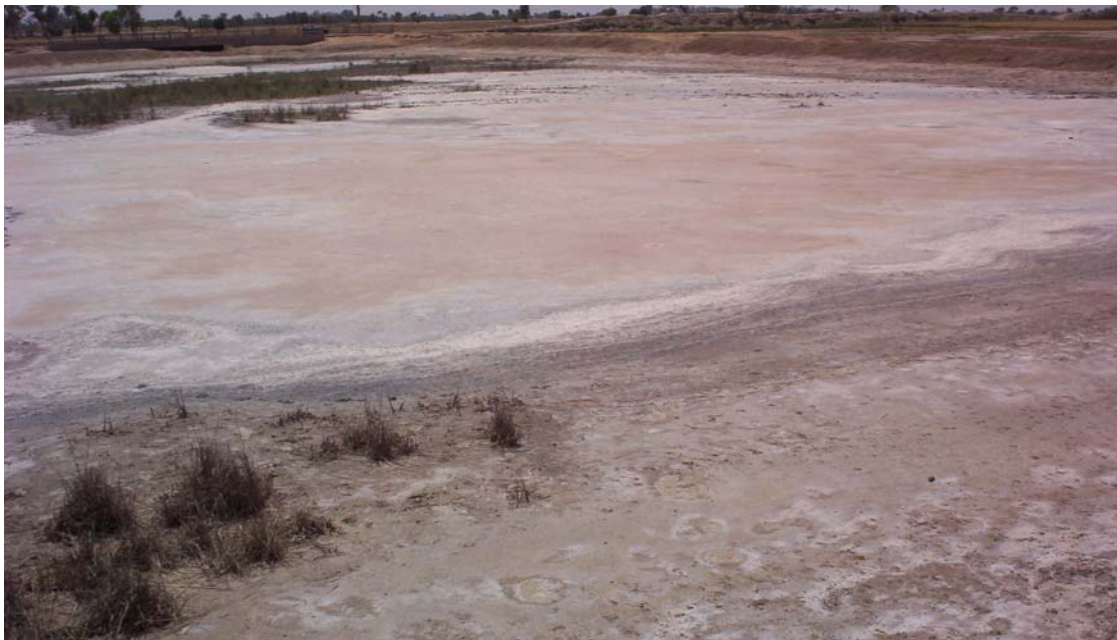
Figure 9. Soil surface covered with white salt crust. Village: Baja Marar, Tehsil: Muktsar.

brackish ground water in order to compensate for the shortfall which ultimately adds to salt accumulation in the soil and affects the crop yield adversely (Figure9). Secondary salinity appears to be linked to the use of poor quality water drawn from the water table with a higher salinity than water drawn from the irrigation canals.

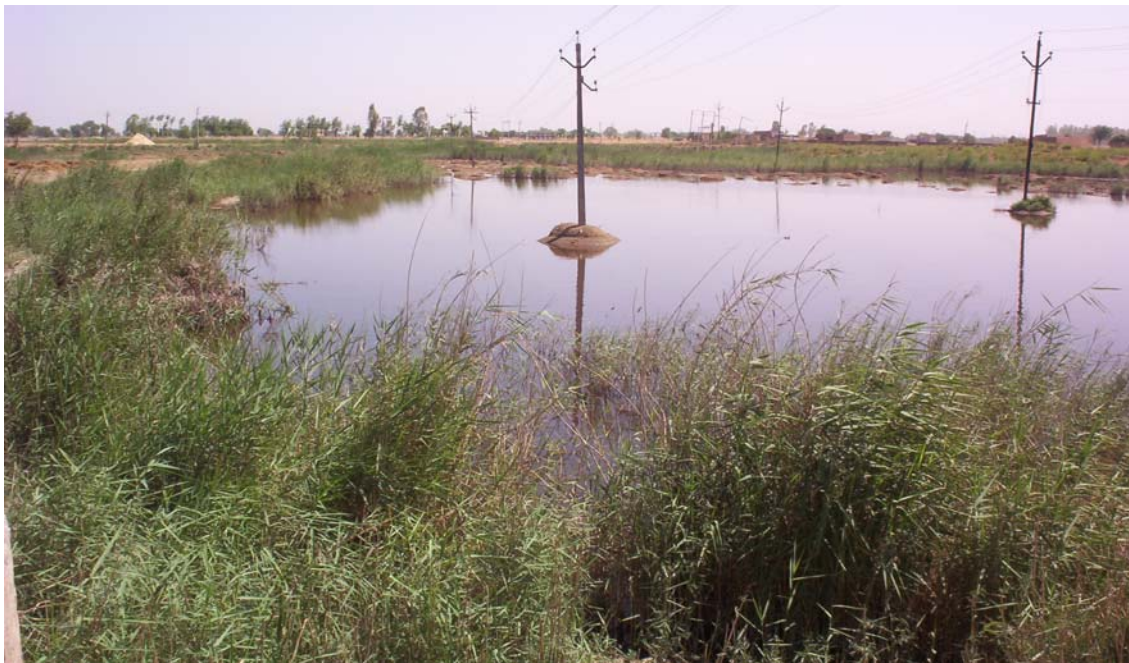
Figure 10. Surface ponding in natural topographic depressions. Village: Sarai Naga, Tehsil: Muktsar.

4) **Buried palaeochannels and topographic depressions:** There exists a well defined channel network of the buried palaeochannels left by once flowing Sutlej River through the region. These channels especially during monsoon season get activated and bring down excess rainfall and irrigation water applied to the paddy fields from the central part of Punjab, which is at a topographically higher elevation than the south-western part. The area having a low lying topography has numerous topographic depressions (especially in Muktsar tehsil), which are poorly drained topographically and remain waterlogged throughout the year (Figure10). Thus allowing a greater detention of water on the land causing more percolation and an increase in the ground water table, contributing towards waterlogging and subsequently salinity. These depressions have fine grained soils where by the primary salinity appears to be linked.

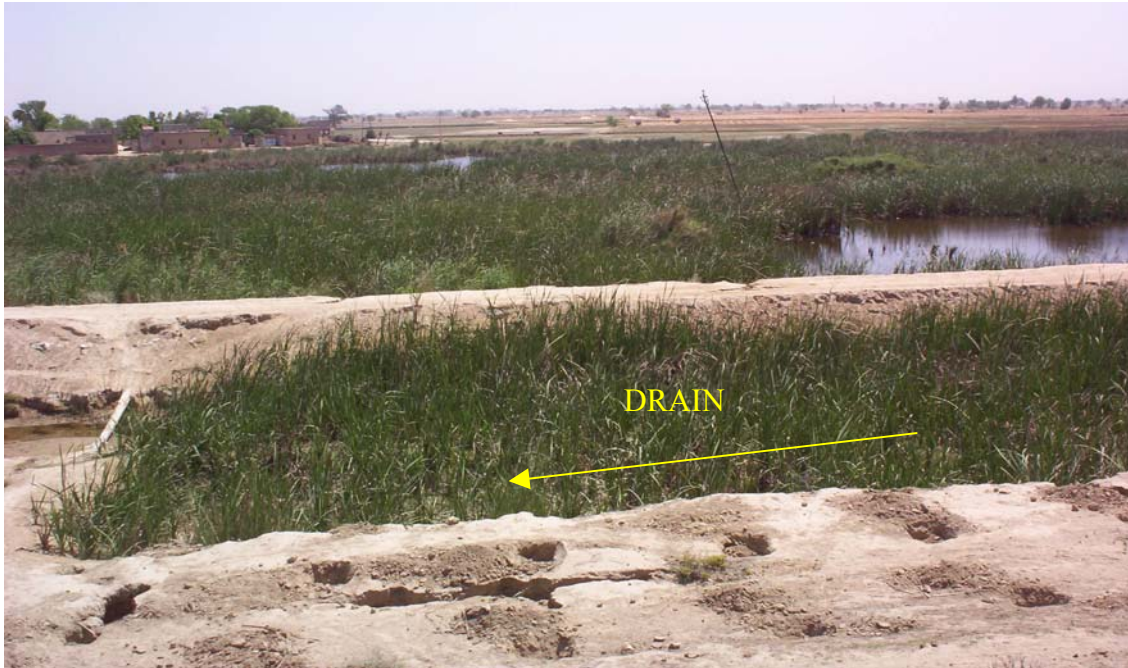
Figure 11. Drainage congestion due to wild grass growth. Village: Theri, Tehsil: Gidderbaha.

6) **Drainage Congestion:** The field survey has shown that most of the drains constructed for dewater logging the areas have been choked by debris and weed growth (Figure11). Thus having reduced there carrying capacity and losing the main objective but contributing to the rising of water table. Due to which there is no proper disposal of excess water during post monsoon season which leads to subsequent rising of the water table and hence contributing to waterlogging problem.
